# CASE STUDY

## BALANCE MACHINERY LUFFING CYLINDERS REFURBISHMENT

# PRESSURE DYNAMICS

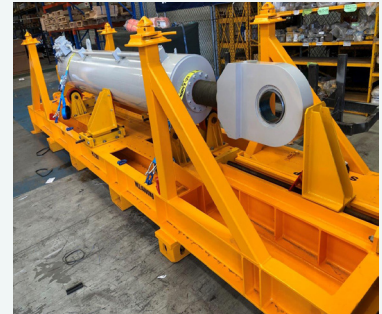
Image 1: Hydraulic Boom Luffing Cylinder

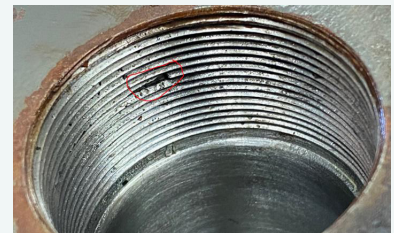
The team conducted a comprehensive strip and inspection of the cylinder, including all associated manifolds, valves, and pipework. While the overall condition of the cylinder and external components was within acceptable tolerances, critical issues were identified within the pressure relief valves, including thread damage, seized components, and corrosion. Due to the risk of future leak paths and the critical nature of the equipment, Pressure Dynamics recommended full replacement of the manifold and associated components rather than repair. Following client approval, the team completed the refurbishment, incorporating a modified bolting arrangement to address previously undocumented changes to the cylinder. The assembly then underwent final testing to verify performance and compliance.

Image 2: Damaged Thread

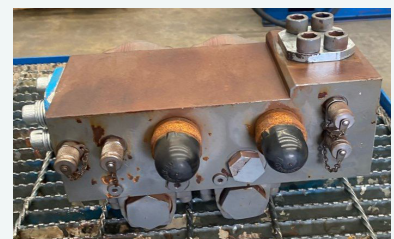
Image 3: Valves
