# CASE STUDY

## TUG WINCH OVERHAUL ON SVITZER GLENROCK

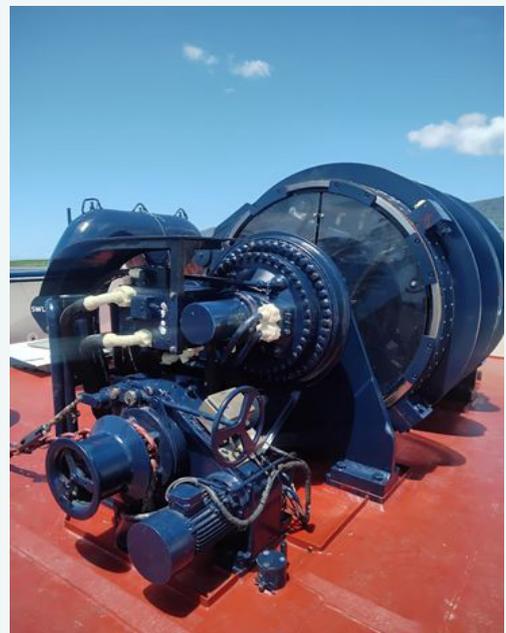
The project scope included the complete removal, disassembly, overhaul, and reinstallation of the tug winch system. Key components serviced included the HÄGGLUNDS hydraulic drives and control manifolds, brake and clutch cylinders and pads, and the full replacement of hydraulic hose assemblies.

The overhaul was completed successfully, restoring the performance and reliability of the tug winch system. During final commissioning, the winch performed flawlessly during the line pull test, confirming the quality of the overhaul and readiness for operation. As a result of the team's strong execution and coordination, Svitzer Glenrock was able to return to service a full day ahead of schedule.
